***NPDES  
Inspection Report***

***Steeler, Inc.  
Seattle, WA***

***September 19<sup>th</sup>, 2012***

***Brian Levo  
Environmental Protection Agency, Region 10  
Office of Compliance and Enforcement  
Inspection and Enforcement Management Unit***

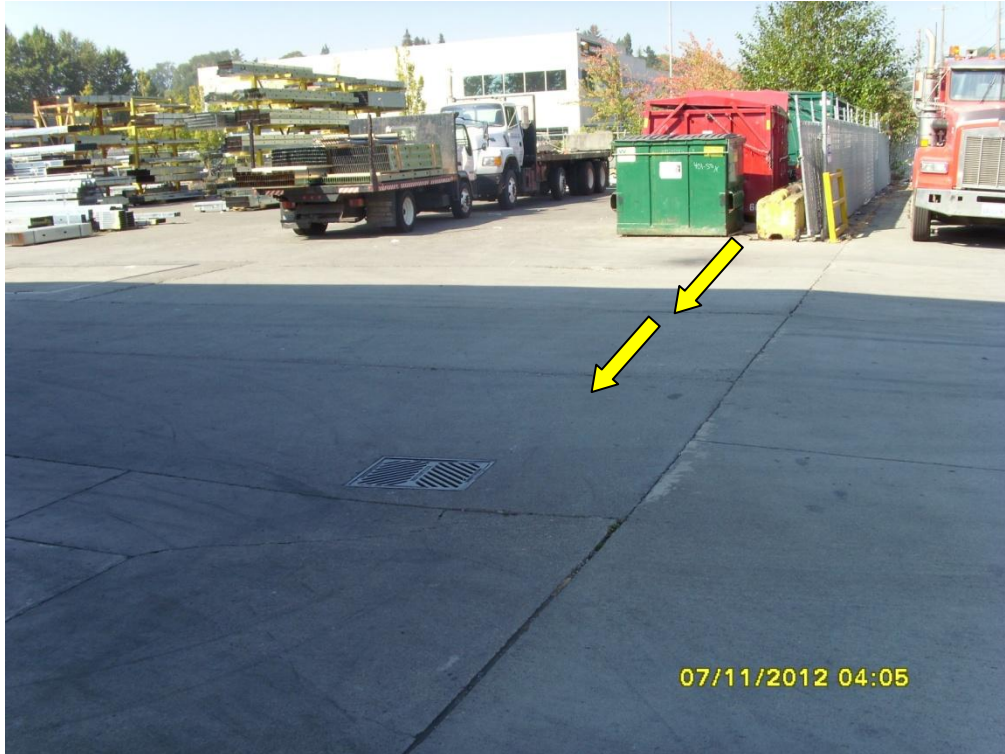
We began the site inspection by examining the stormwater catch basins on the north side of the facility building, located in the storage yard (**Photos 1-4, Attachment B**).

**Photo 1** (SI851652): Northern view along the east side of the facility at the yard entrance. According to the facility, stormwater along the northern fence line channels to the northeastern corner and then is diverted south (yellow arrows) by the slope of the yard to the catch basin pictured here.

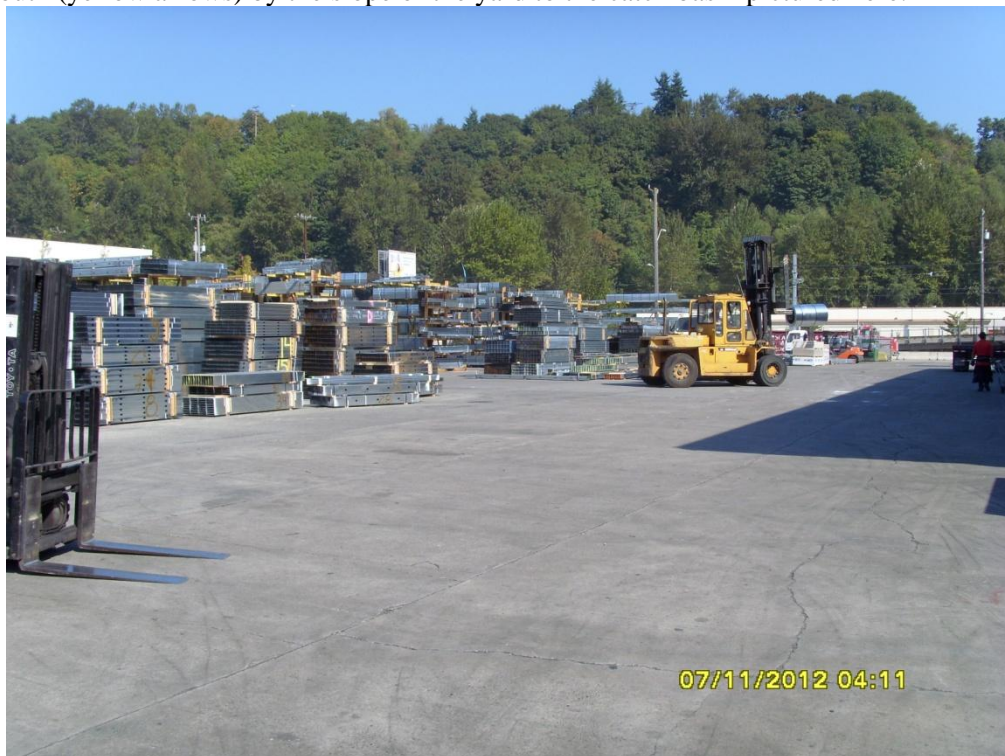
At the time of inspection, galvanized steel product was being stored without cover throughout the facility yard (**Photo 2**). Some of this steel was covering the catch basin furthest upstream in the facility's storm drainage system (located north of the awning on the northwest part of the building) and could not be found. We informed Mr. Hitsman that galvanized steel could be a source of stormwater pollutants such as zinc. Mr. Hitsman told us that SPU had brought up that same concern and that SPU sampled the galvanized steel only to conclude that it was not a significant source of pollution. A copy of the analysis conducted by SPU was not available at the time of inspection.

The facility was storing galvanized steel product in their yard on both the north and south sides of the building (**Photos 2, 3, 6**). While some of this steel was packaged in rolls, it appeared a majority of the product was being stored uncovered. Mr. Hitsman stated that SPU had already sampled the steel and discounted it as a potential stormwater pollution source. We told Mr. Hitsman that without reviewing the SPU sample report, and without reviewing copies of the facility DMRs, we would still consider the exposed galvanized steel as a potential pollution source.

**Photo 2** (SI851655): Northeastern view of outside operations and uncovered galvanized steel product being stored in the yard.

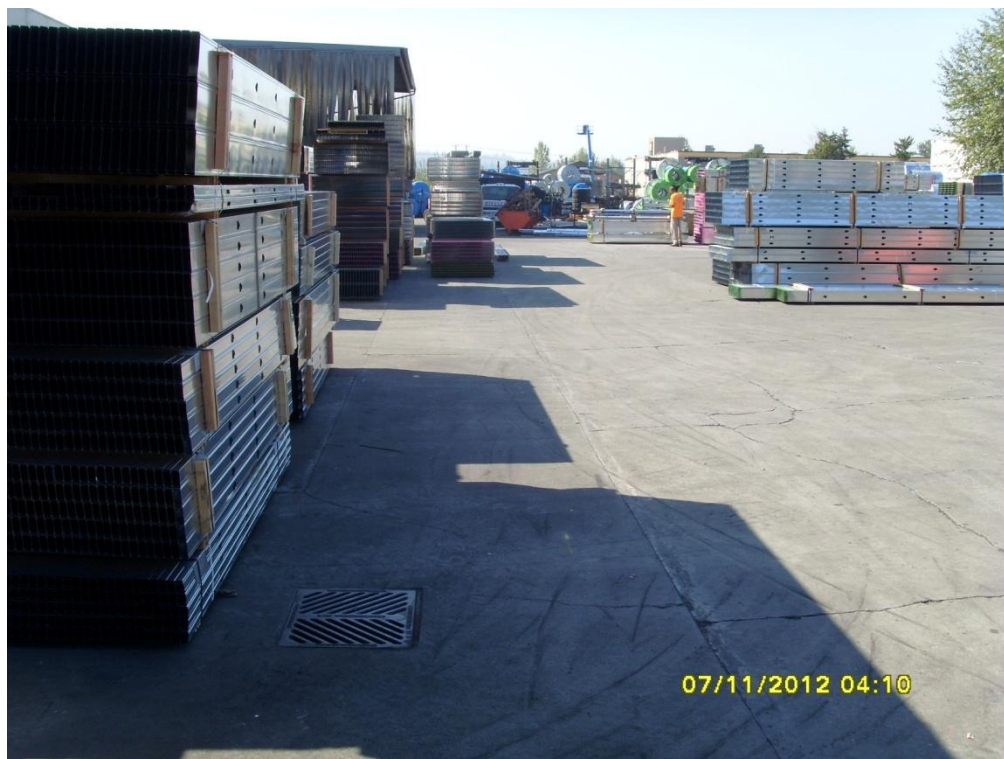
**Photo 3** (SI851654): Western view of the stormwater catch basin located under an awning on the north side of the building. More galvanized steel product stored both under the awning (left) and uncovered in the yard (right).

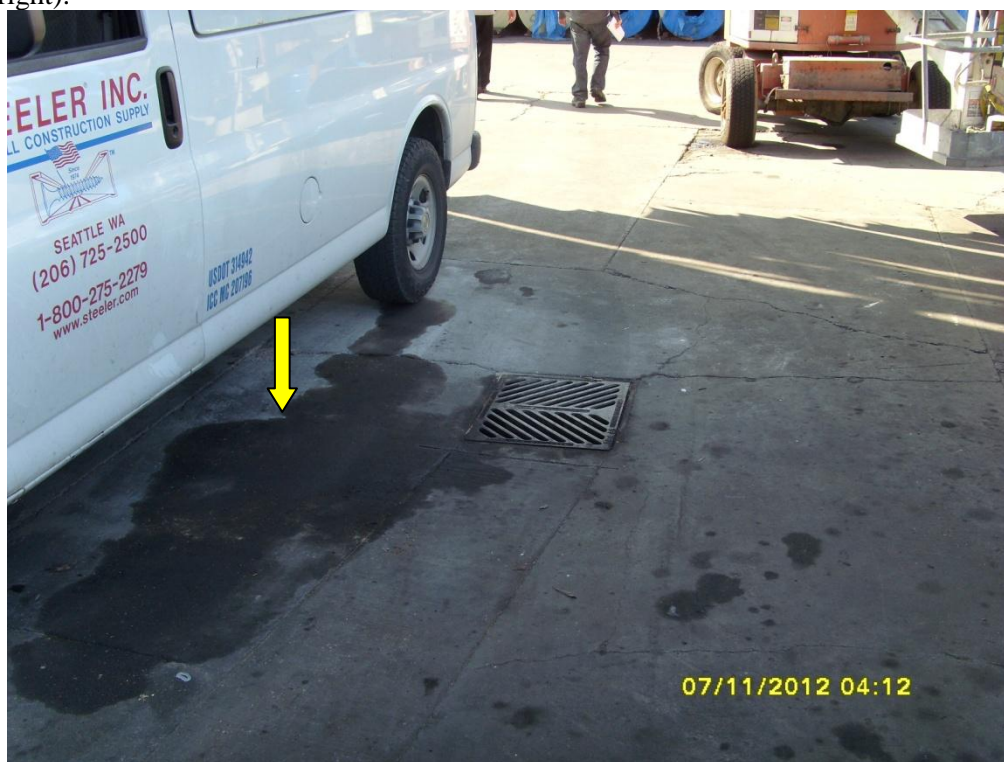
We observed an oil stain near a parked van at the catch basin closest to the northwest corner of the facility (**Photo 4**). Mr. Hitsman asked an employee in the vicinity about the stain. The employee replied that it was an oil leak from a vehicle that occurred about 3 weeks ago and had been cleaned up. Mr. Hitsman also stated that the facility typically has filter socks installed in their catch basins and was unsure why they were not installed. We

did not observe any filter socks installed at the time of inspection. The location of the oil stain also appeared to be the only area where roof runoff was not piped directly underground but instead drains on the concrete surface in vicinity of the catch basin shown in **Photo 4**.

At the time of the inspection there was an oil stain located between a parked van and a stormwater catch basin (**Photo 4**). According to a facility employee, this stain resulted from an oil leak that had occurred 3 weeks ago and had been cleaned up immediately.

It is unclear if the facility implements BMPs for the prevention of spills and leaks. In addition, it does not appear that monthly inspections are conducted.

At the time of inspection, a van was parked in close proximity to a catch basin with an oil stain (**Photo 4**). It is unclear if parking vehicles in close proximity to, or on-top of, stormwater catch basins is a regular occurrence. We informed Mr. Hitsman that we were concerned of the possibility of additional vehicle fluid discharges into the storm drains.

**Photo 4** (SI851656): Western view of the stormwater catch basin at the northwest corner of the building, also located under an awning. Note the oil stain (yellow arrow). According to the facility, this spill occurred approximately 3 weeks ago and was cleaned up immediately after it occurred.

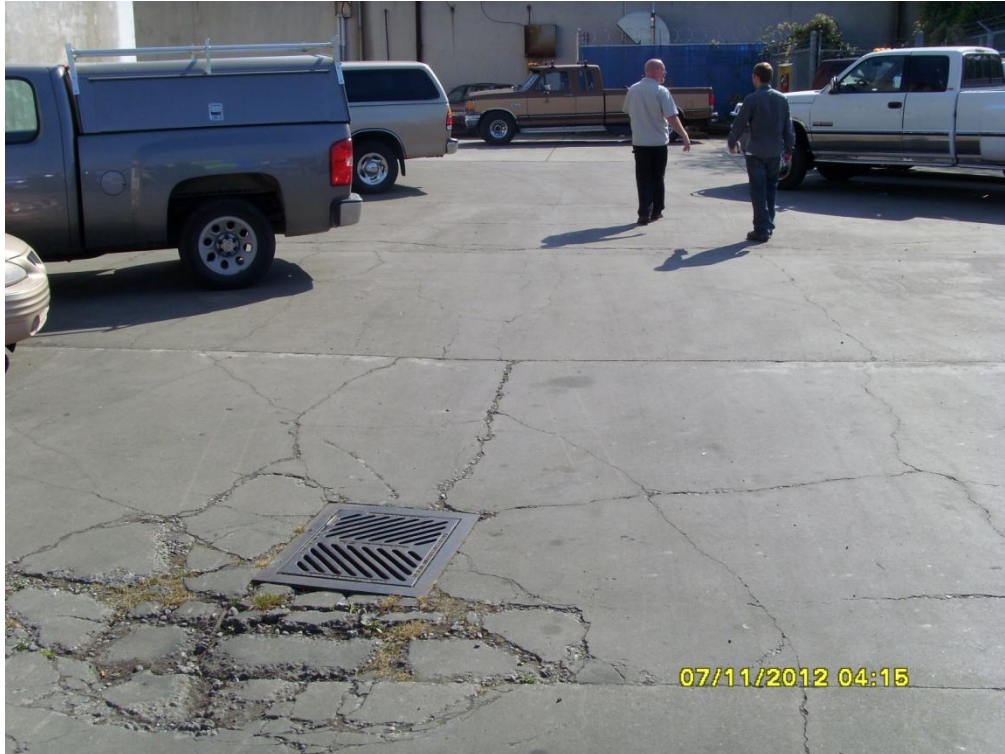
There was a catch basin on the west side of the facility (**Photo 5**) that Mr. Hitsman said flows south and connects to the last catch basin before stormwater discharges off-site. Mr. Hitsman told us that the storm sewer lines discharge off-site at the southwest corner of the property to a stormwater catch basin of the neighboring Papé Material Handling business. From there, Mr. Hitsman explained, the stormwater then discharges from Papé Material Handling to a drainage ditch that inevitably discharges to the Duwamish River.

**Photo 5** (SI851659): Southern view of catch basin on the west side of the building. According to the facility, this drain flows south towards the settling tanks.

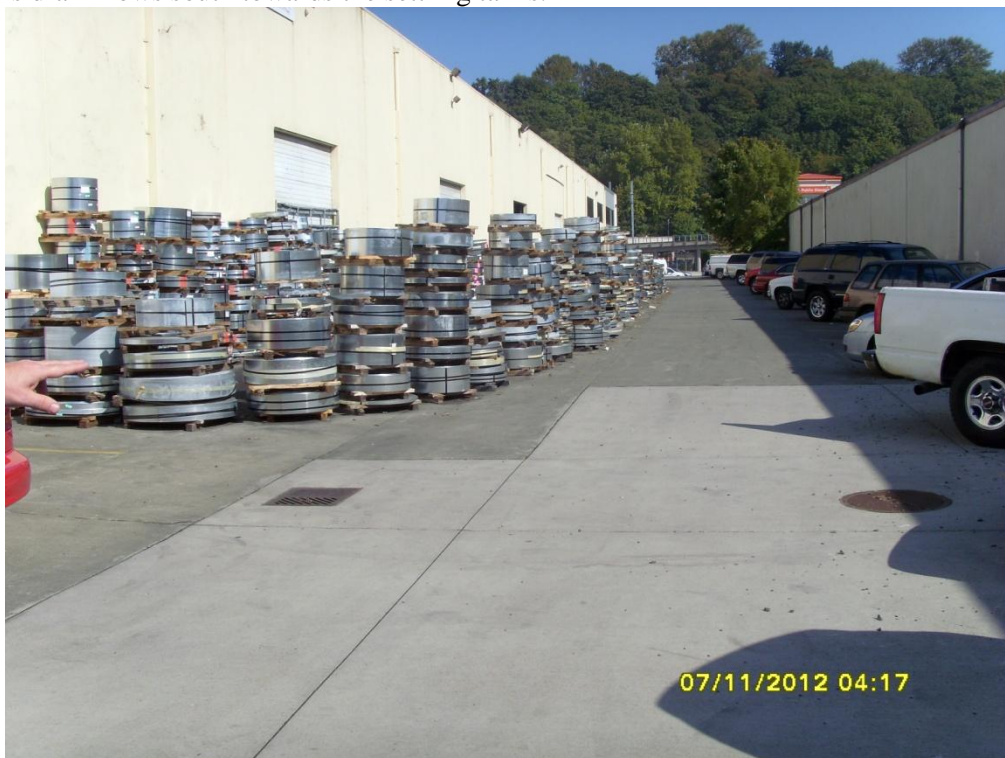
Before discharging off-site, Mr. Hitsman told us there are a series of three belowground settling tanks installed at the catch basin located at the southwest corner of the facility (**Photo 6**). He claimed that all stormwater passes through these settling tanks before being discharged. He also told us that SPU required that the roof drainage from the neighboring facility to the south of Steeler Inc. be piped belowground into the Steeler Inc. storm sewer system (**Map 1**).

At the time of inspection, additional galvanized steel parts were being stored uncovered on the south side of the building (**Photo 6**). Mr. Hitsman pointed out a barrel being stored under cover that collects compressor condensation (**Photo 7**). Mr. Hitsman told us that SPU required that the facility collect the condensate instead of allowing it to discharge into the storm sewer. Mr. Bott explained that discharge of compressor condensate is allowed by the ISGP, but may not be allowed by the City of Seattle.

**Photo 6** (SI851660): Eastern view of the south side of the building (left). According to the facility, three stormwater settling tanks are located beneath these drains.

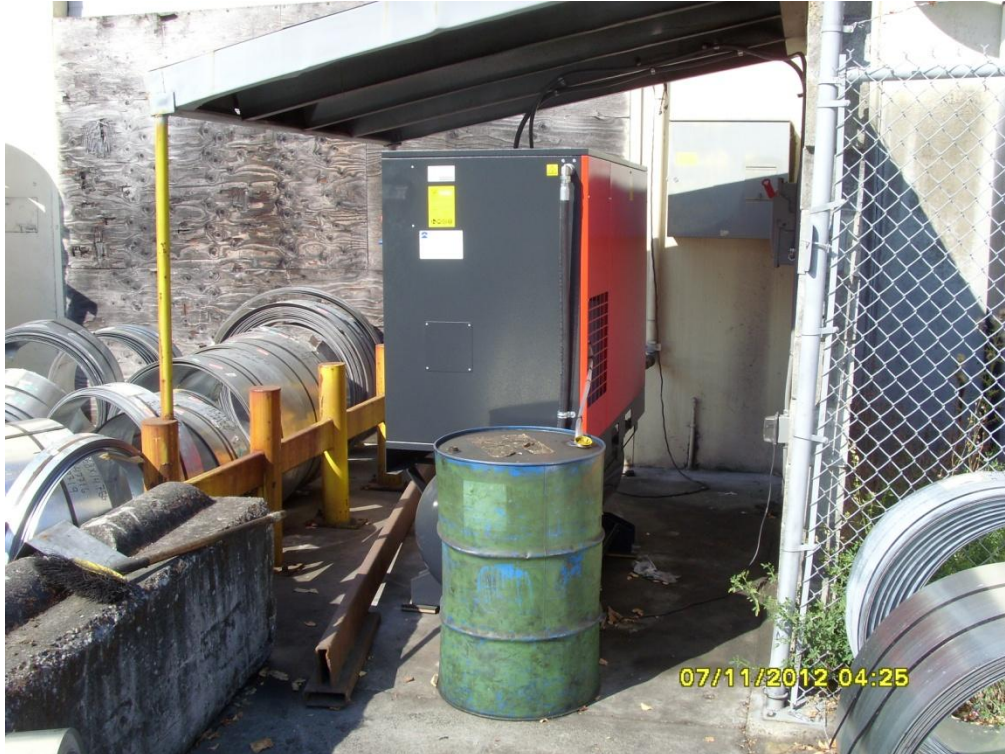
**Photo 7** (SI851662): Compressor condensate storage drum located under cover on the south side of the building.

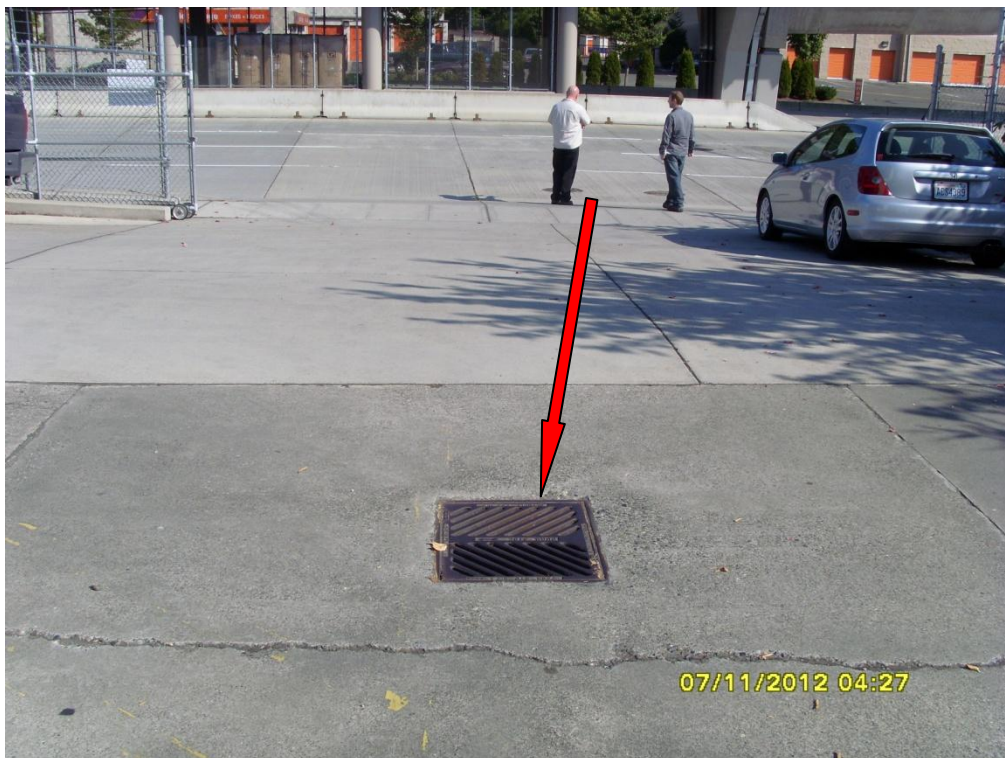
Mr. Hitsman showed us the catch basin near the southeast corner of the building and explained that the City of Seattle has its storm sewer system connected to this catch basin (**Photo 8**). He said that the city's storm drain flows south along Martin Luther King Jr. Way S. and then diverts across the Steeler Inc. property through the southern half of their storm sewer lines, settling tanks, and through their discharge point (**Maps 1 & 2**).

**Photo 8** (SI851663): Eastern view of the catch basin near the southeastern corner of the building. According to the facility, the city storm sewer system flows from the street to this catch basin (red arrow) and then flows to the southwest corner of the facility where it discharges through the Steeler Inc. discharge point.

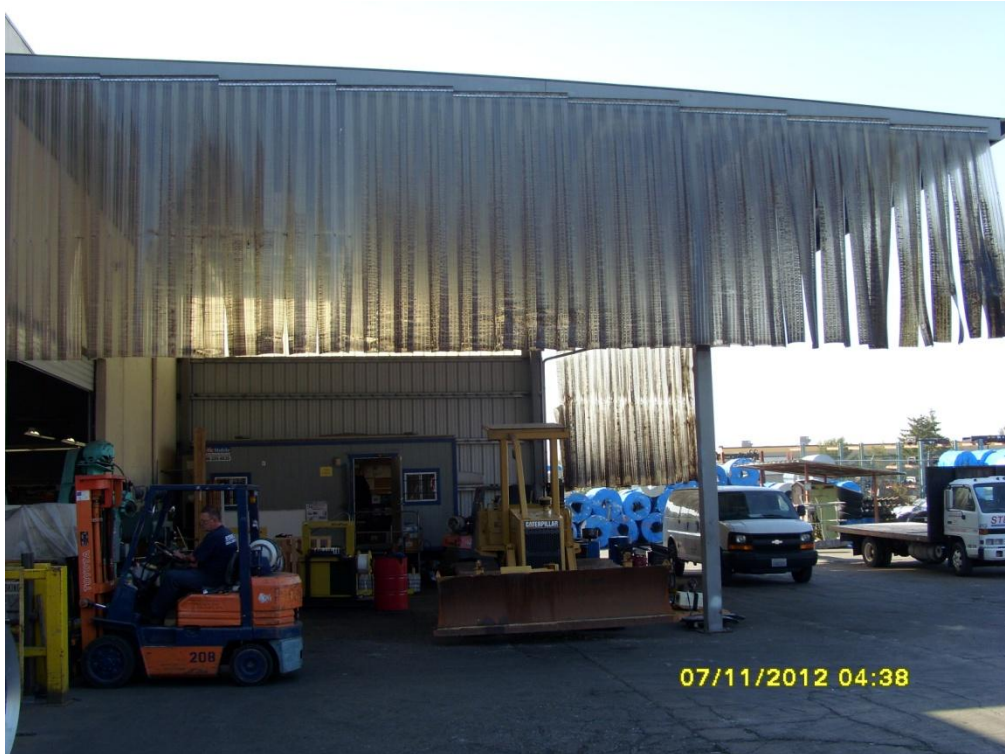
The north side of the facility building had multiple metal awnings extending out from the building roof. We asked Mr. Hitsman where roof runoff goes and he informed us that roof drainage is piped belowground where it connects to the storm sewer lines. The awnings provide additional storage space for galvanized steel product as well as storage for other supplies and equipment. I noticed that two of the awnings had flaps hanging from down from their roofs (**Photo 9**). At the time of inspection, the facility was operating with some of its doors open on the north side of the building. Mr. Hitsman said that one of the main operations conducted inside the building was steel cutting, a process that requires lubricant oil, and that the flaps help reduce the amount of lubricant oil residue that could deposit on yard surfaces exposed to stormwater. Mr. Hitsman also stated that that facility plans on extending awning coverage on the north end of the building to close the gap between the two main sections of awning currently in place.

**Photo 9** (SI851674): Western view of an awning on the northwest side of the building. Note the awning has flaps to reduce lubricant oil (used for steel cutting) residues from depositing on surfaces exposed to stormwater.

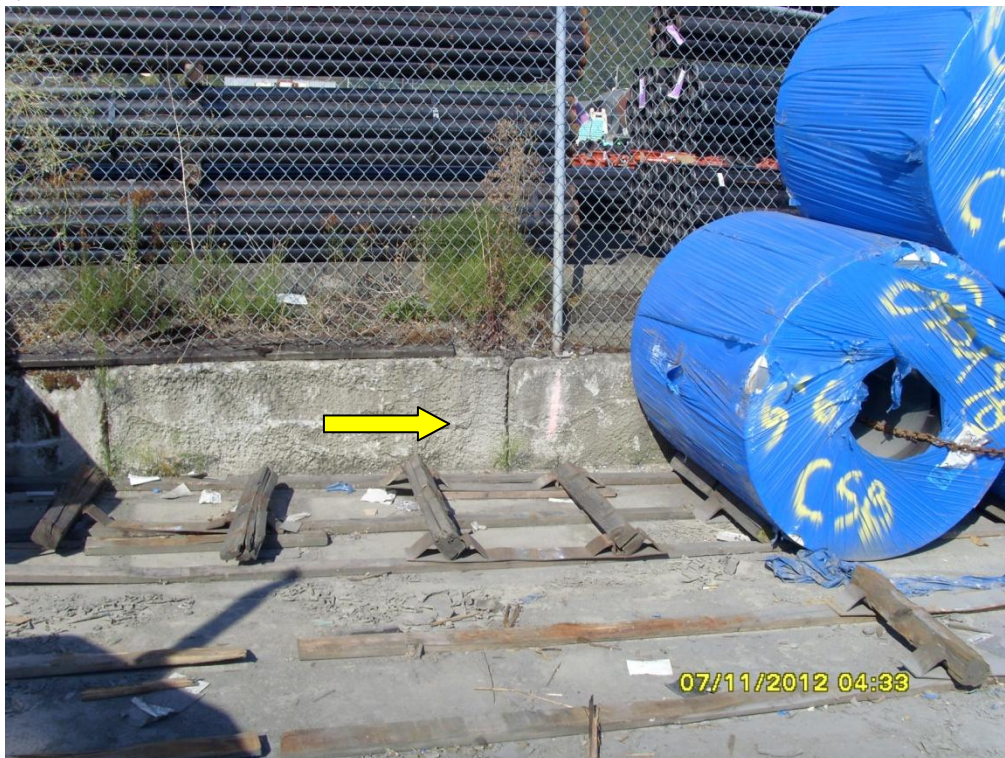
Finally, we walked the northern perimeter of the facility. Mr. Hitsman told us that stormwater on the north side of the property flows west to east along the northern perimeter towards the northeast corner of the facility. He pointed out a raised concrete surface that inhibits stormwater from flowing north onto the neighboring property (**Photo 10**). Once the stormwater reaches the northeastern corner, Mr. Hitsman claimed that the slope of the yard channels the stormwater south to the catch basin located near the northeast corner of the building (**Photo 1**). The northern section of the yard appeared to slope east, but there did not appear to be a slope or any structure in place to divert stormwater runoff south. Instead, it appeared that stormwater would continue flowing east outside the facility fence and into the street (**Photo 11**). Mr. Hitsman admitted that some of the stormwater drainage might make it out to the street, but he pointed out that any drainage discharged into the storm drains along the street would flow right back into the facility's storm sewer system at the catch basin near the southeast corner of the Steeler Inc. building.

**Photo 10** (SI851669): Northern view of fence line. According to the facility, stormwater flows from west to east along this boundary (yellow arrow).

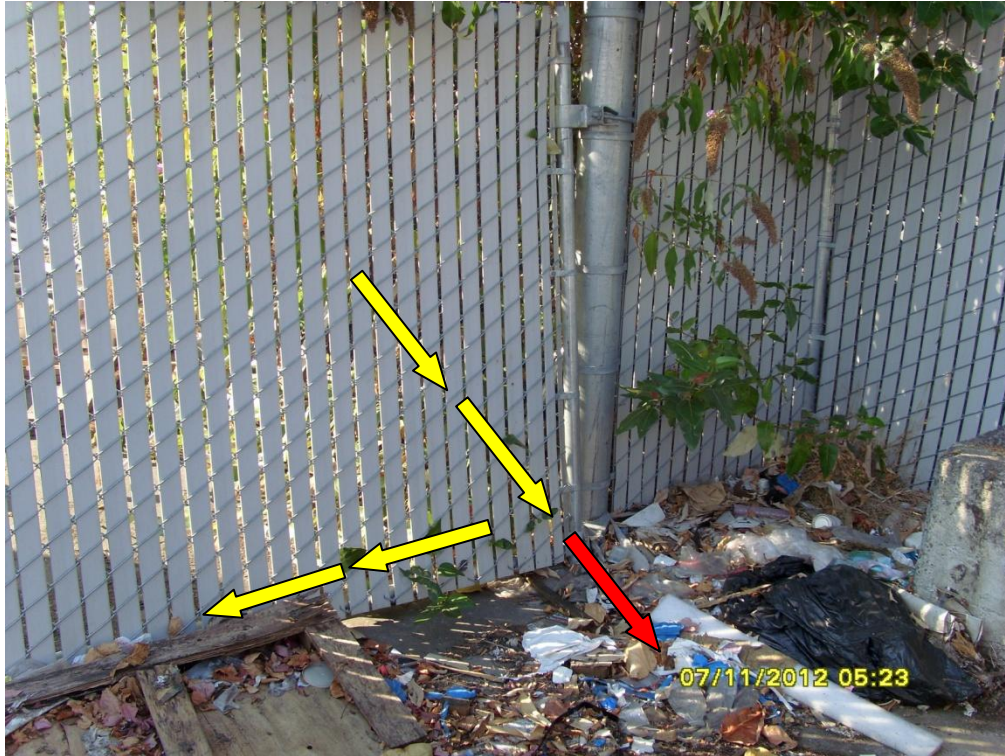
**Photo 11** (SI851676): View of the northeastern corner of the facility yard from outside the fence. According to the facility, stormwater follows the fence line along the north side of the property and is diverted south from this corner to the storm drain shown in **Photo 1** (yellow arrows). However, at the time of inspection, it appeared that stormwater would most likely continue flowing east past the fence and into the street (red arrow).
